Railway Project

Water wells survey in three sections of the railway

AUGUST 2017

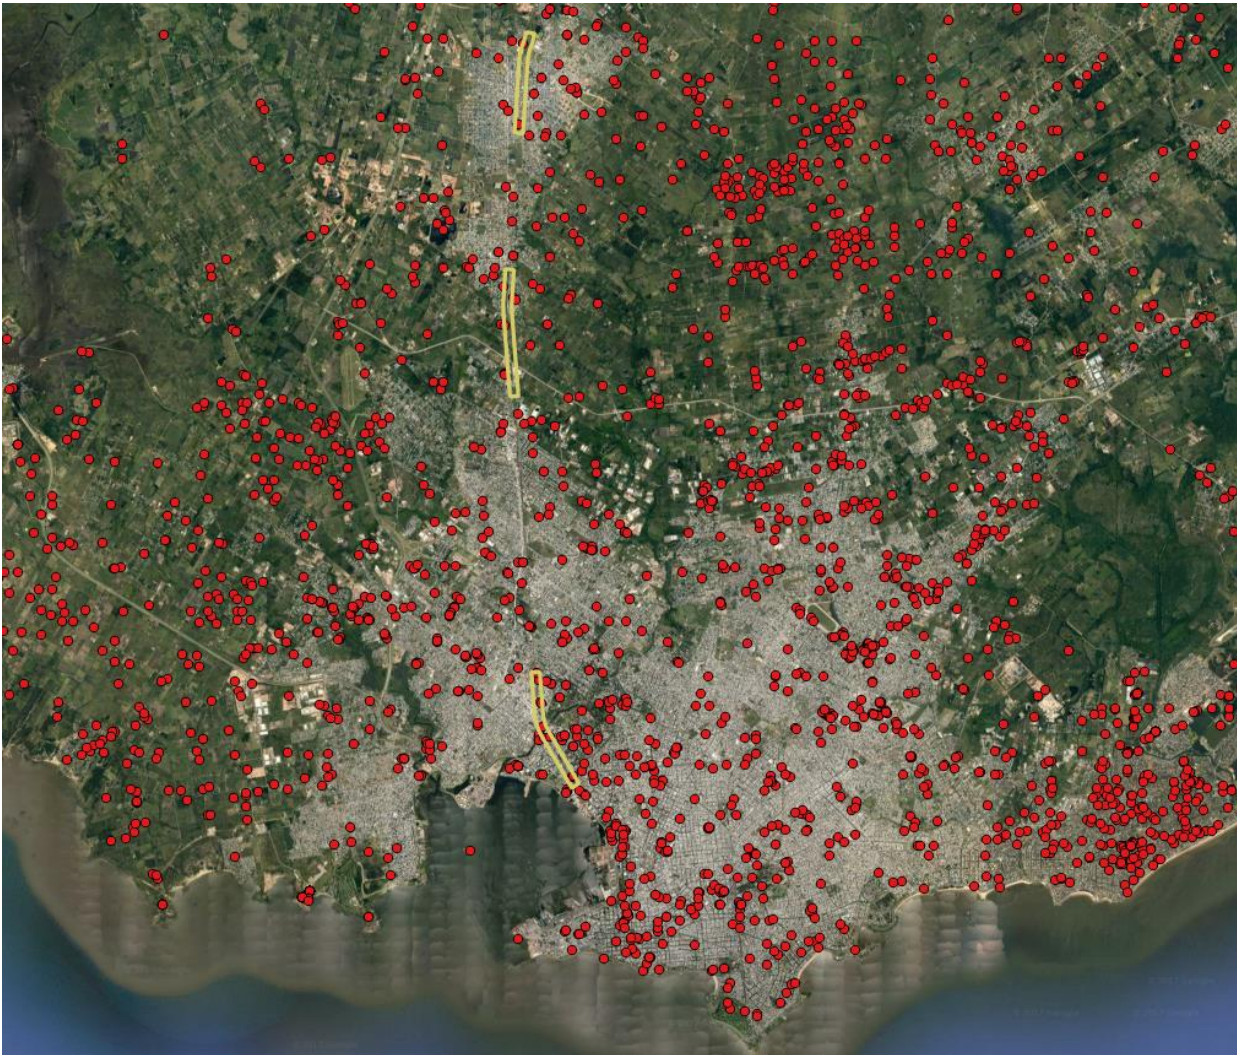
Figure 1 - General view. DINAMIGE's documented wells in the area (red dots) and the three study sections (in yellow).

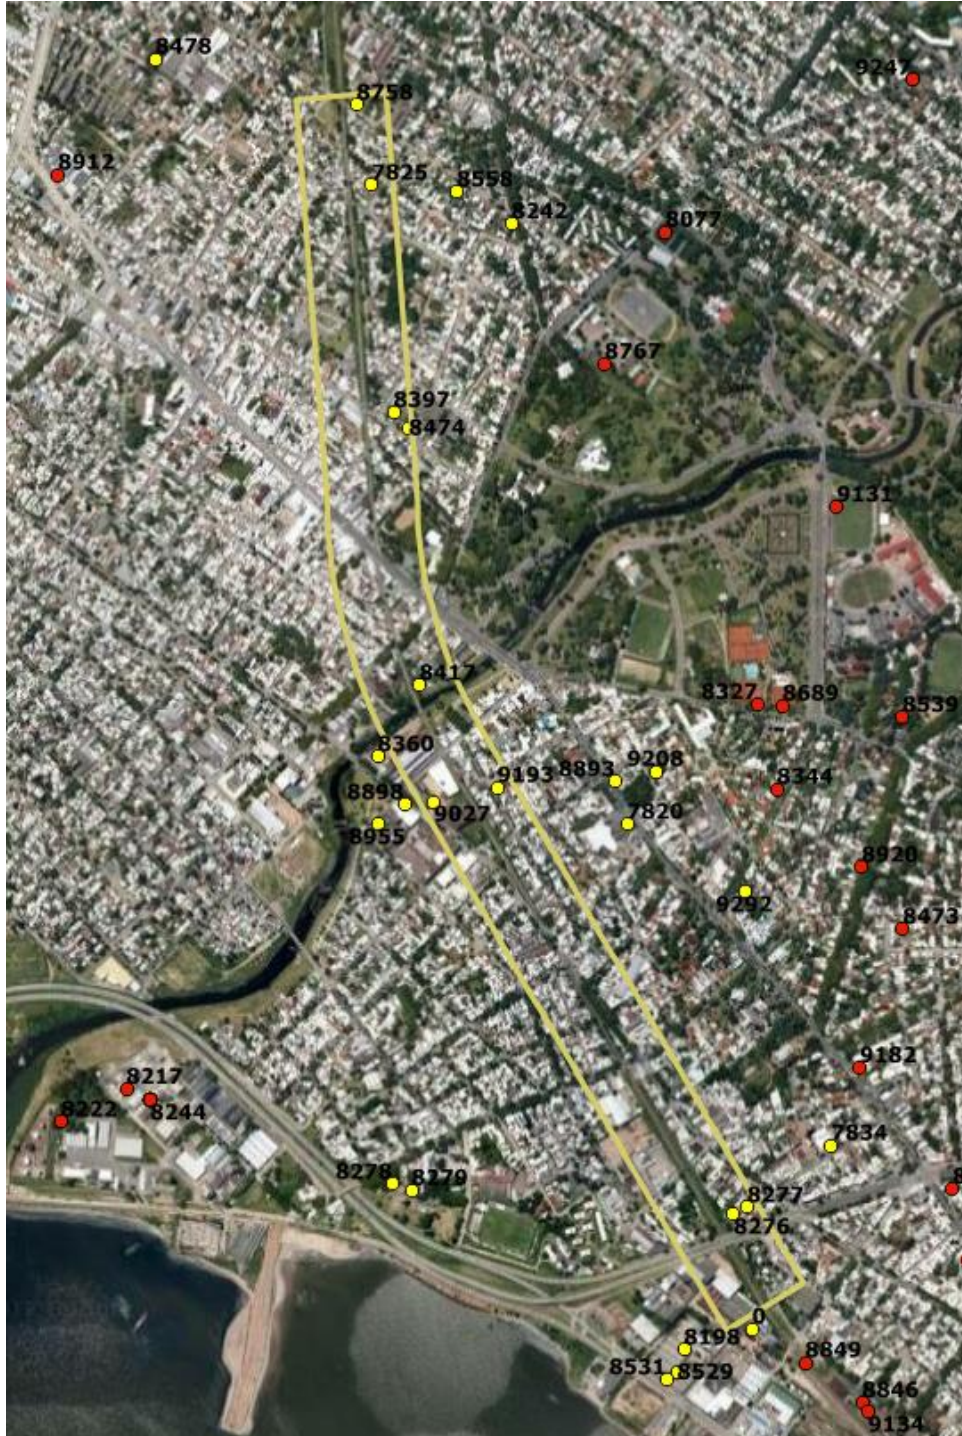
Figure 2 - Study section 1 and wells of interest (yellow dots).

During a previous selection, there were identified 28 wells close to the area of interest. From this selection, a total of 26 wells were finally visited. Furthermore, an existing perforation was found, which was not documented by DINAMIGE (Well number: 0). In some cases, DINAMIGE’s data indicates that there exists (or existed) more than one perforation per property.

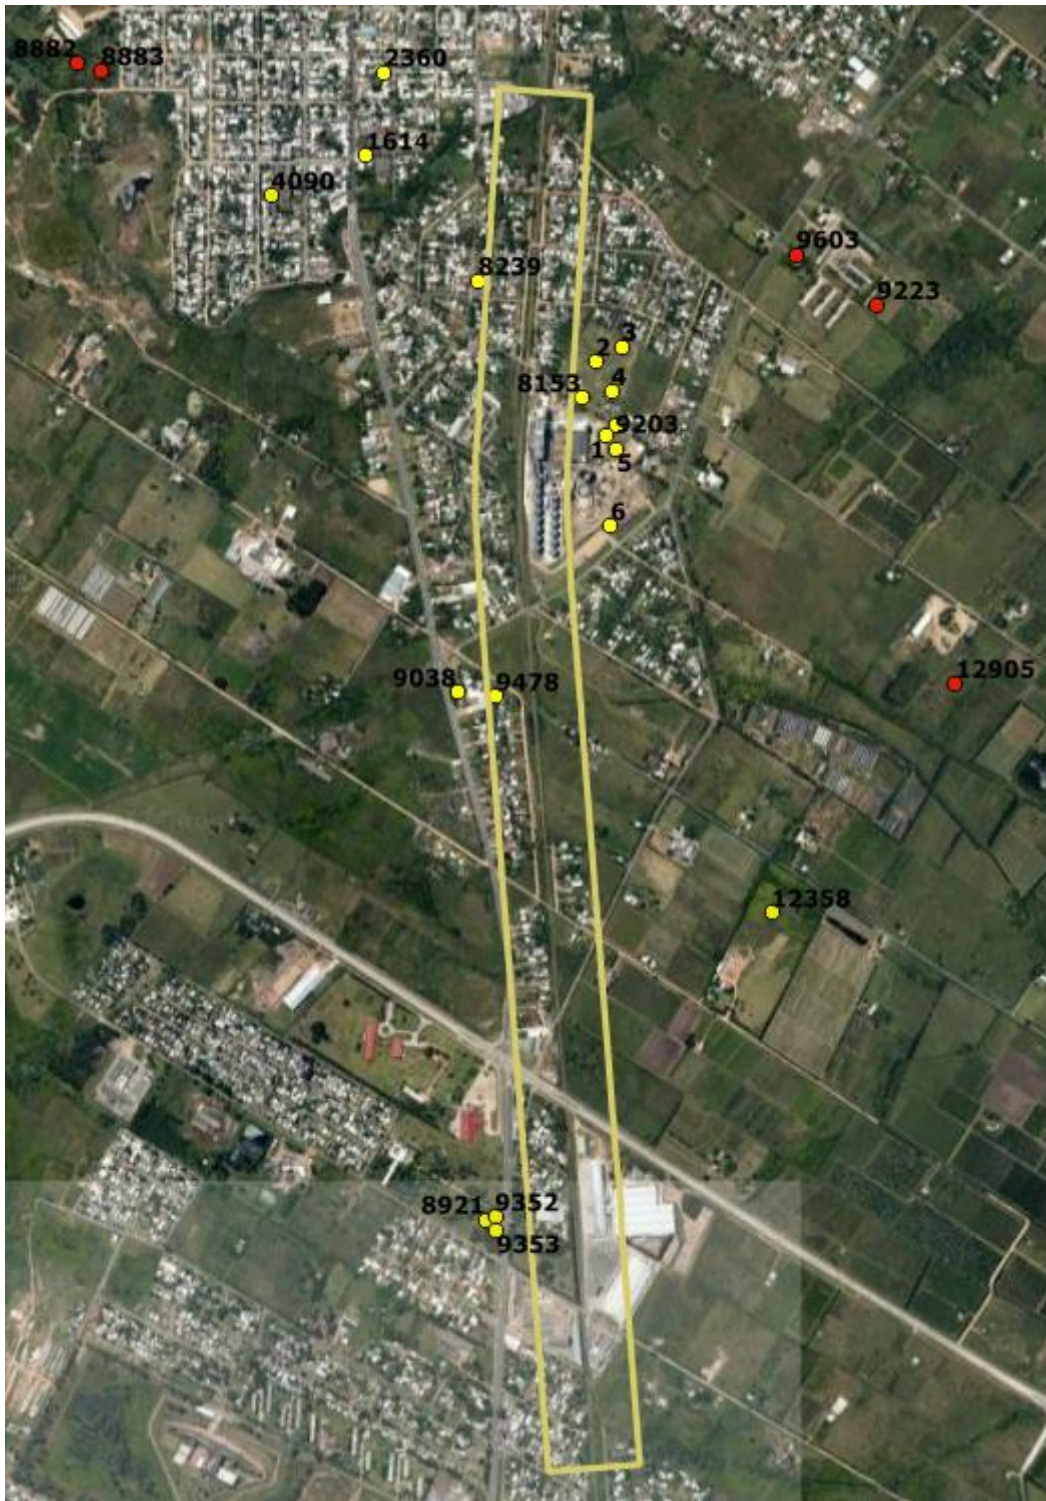
Figure 3 - Study section 2 and wells of interest (yellow dots).

During a previous selection, there were identified 13 wells close to the area of interest. From this selection, a total of 10 wells were finally visited. Additional information regarding 6 perforations (well numbers 1 to 6) was acquired thanks to “Maltería Oriental SA”, since they carry out a periodic monitoring in existing wells close to their property. In some cases, DINAMIGE’s data indicates that there exists (or existed) more than one perforation per property.

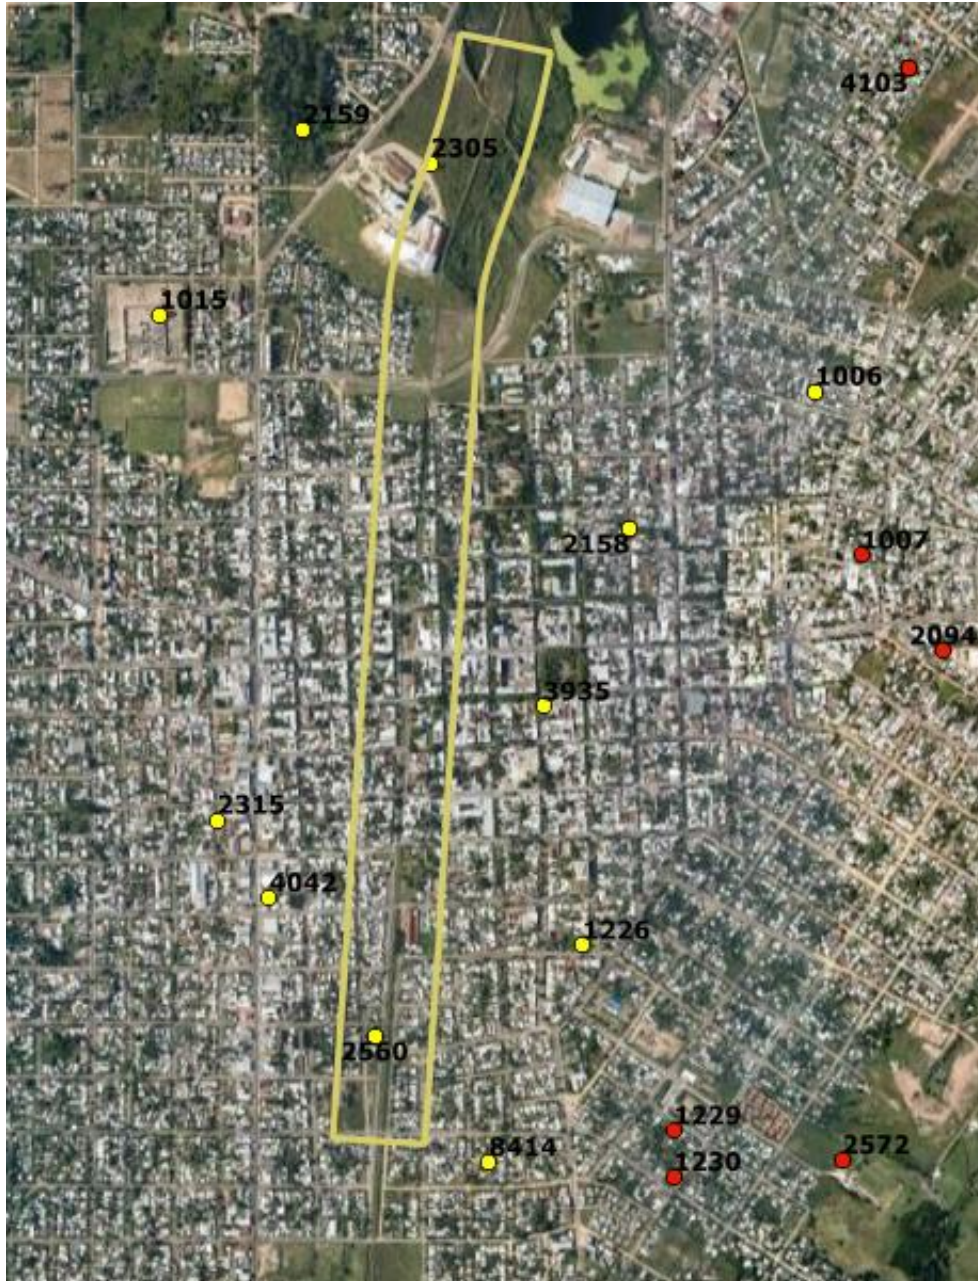
Figure 4 - Study section 3 and wells of interest (yellow dots).

During a previous selection, there were identified 13 wells close to the area of interest. From this selection, a total of 12 wells were finally visited. In some cases, DINAMIGE’s data indicates that there exists (or existed) more than one perforation per property.

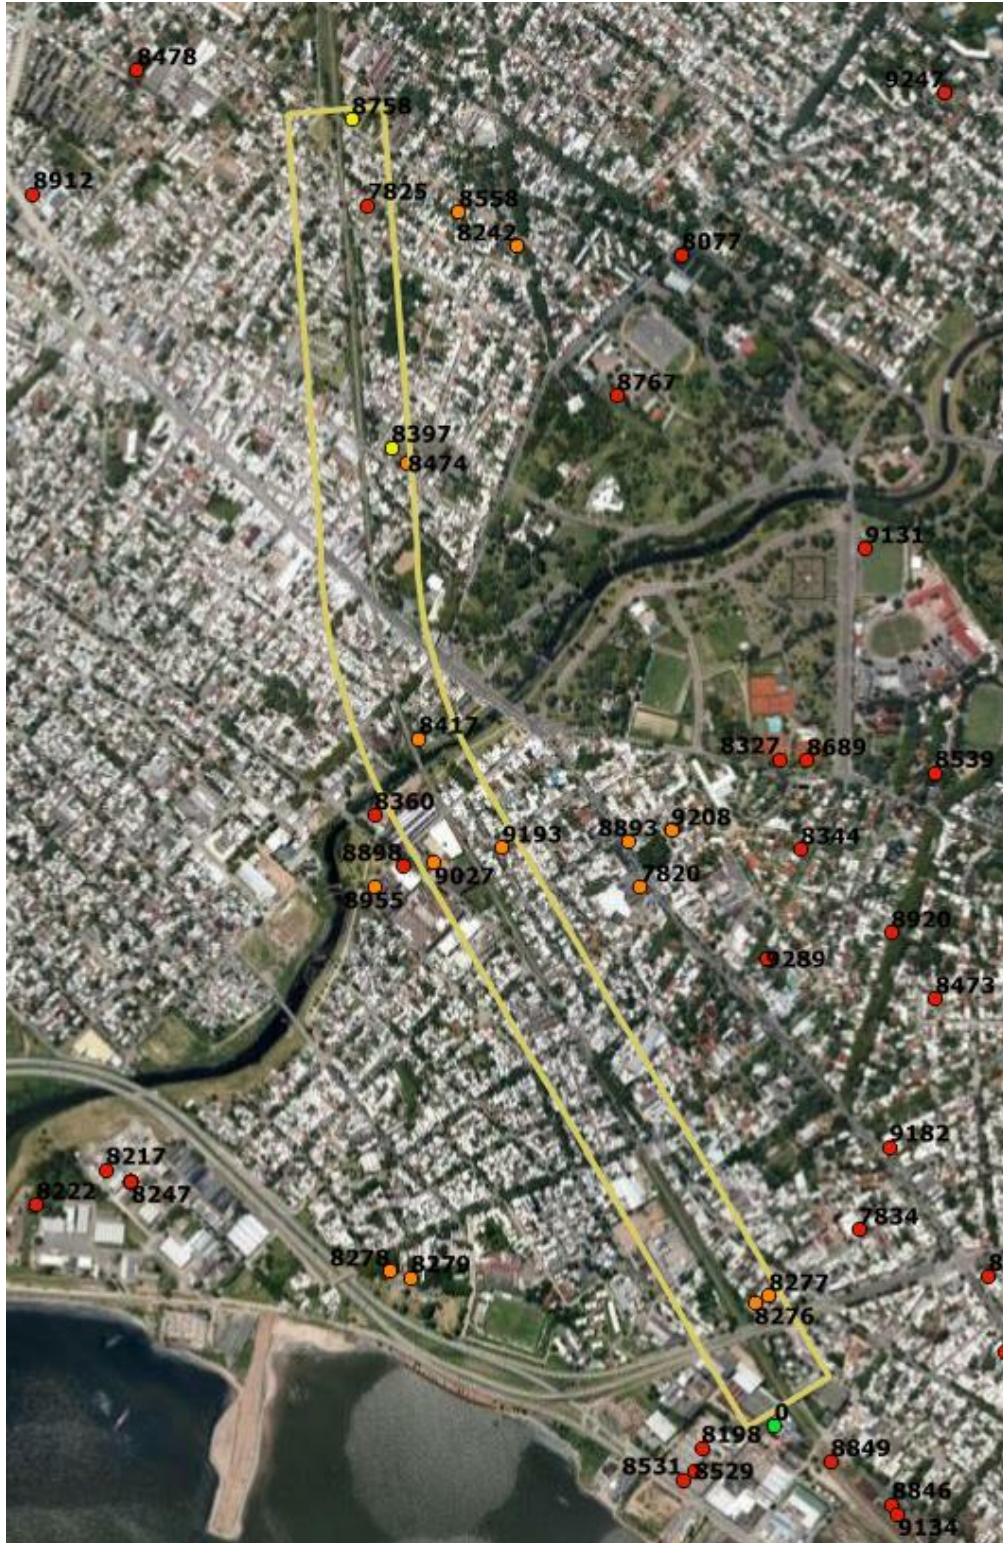
Figure 5 – Section 1

- Category C (in yellow colour): Connected to OSE, possible water well in the property, not in use (neither necessarily accessible)
- Category D (in green colour): Water well in use
